The Wreck of the Brig *Sultan*: An Archaeological Investigation

Brig Sultan

Maritime Archaeological Survey Team

February 2016

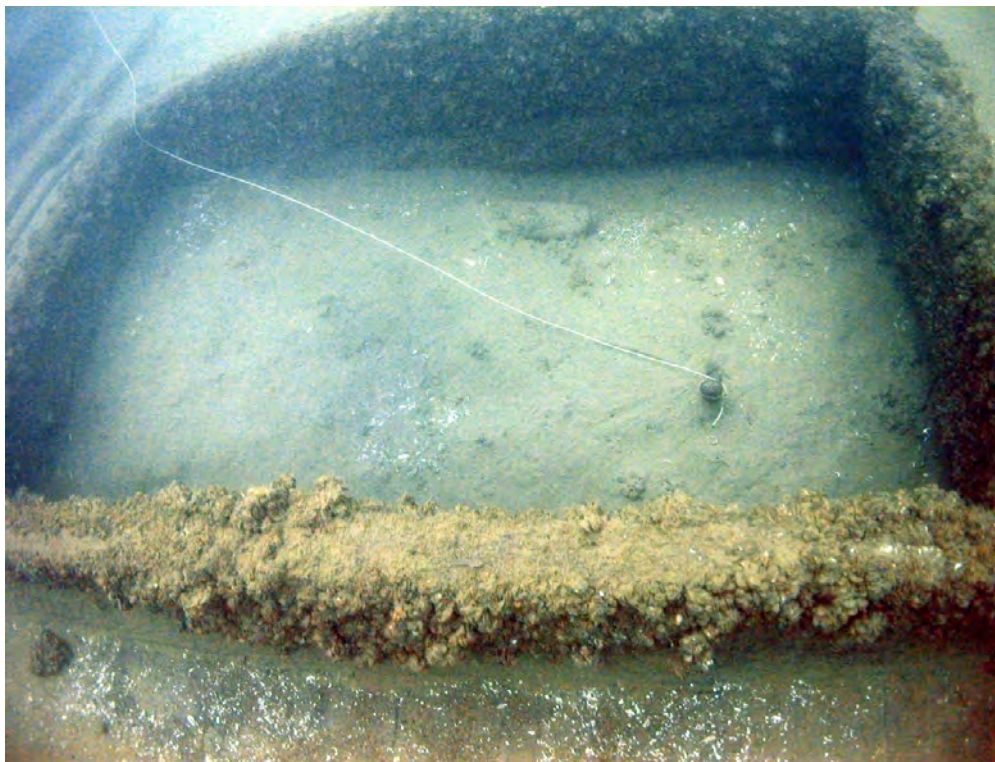
The *Sultan*, Ohio Archaeology Inventory (OAI) number 33 CU 534, is located at 41° 35.685' N, 81° 36.936 W and sits upright on a sand/mud bottom in 42 feet of water. The wreck measures approximately 125 feet x 23 feet and is mostly intact although partially buried with the hull settled into the sand/mud on to a firmer sub-bottom. Silt has filled the interior spaces of the vessel (Figure 30), but a slight west-to-east current helps keep the upper structure of the wreck free of major silt. Due to its depth the wreck is not subject to shallow water ice damage, wind-driven surface currents, or wave action. Zebra or quagga mussels cover the vertical surfaces of the wreck to a moderate degree, necessitating the use of gloves by divers to prevent cuts from the sharp mollusk shells (Figure 31).

Figure 30 Silt-filled hold (Photo by David VanZandt, CLUE)

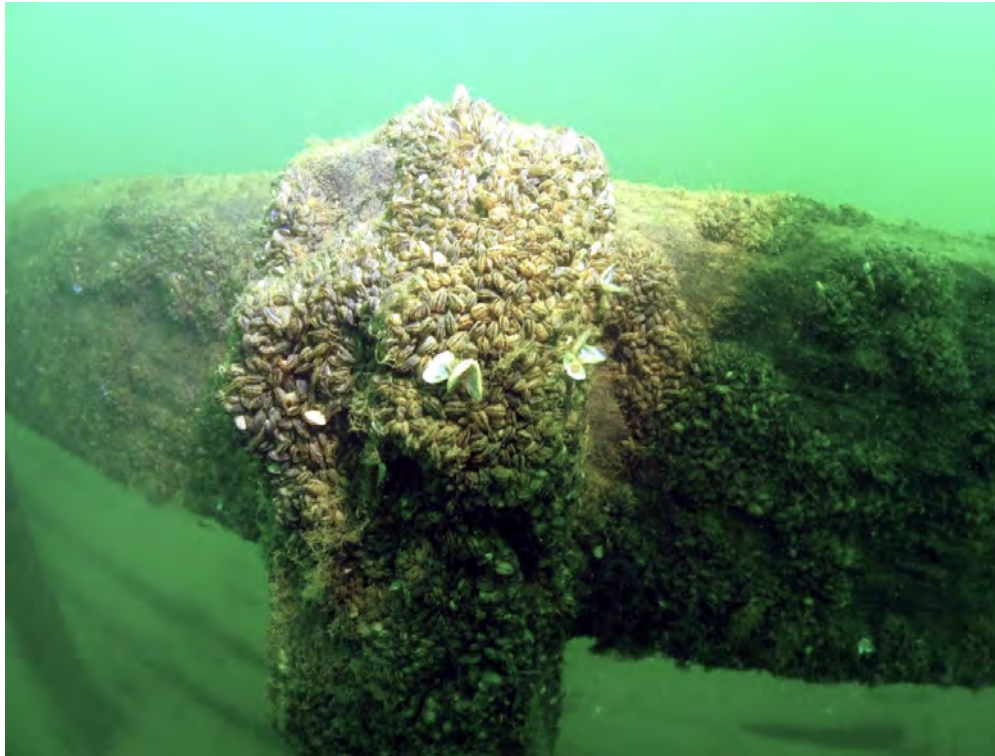
Figure 31 Mussels (Photo by David VanZandt, CLUE)

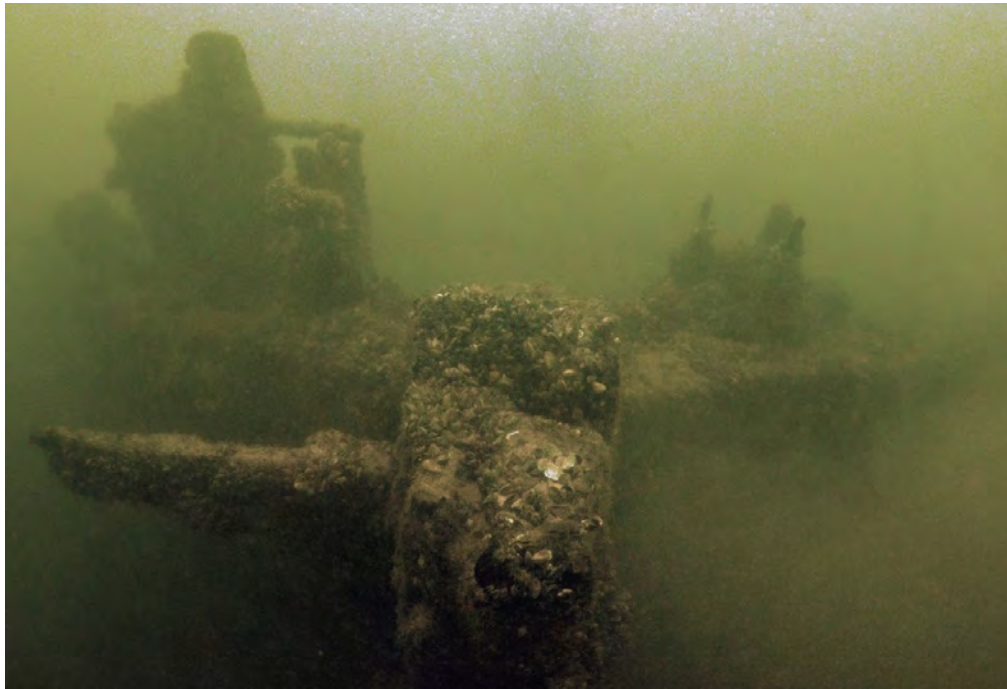
The ship's bow, missing the bowsprit, is pointed east and stands five feet high off the sand/mud bottom (Figure 32). The hull sides are intact and the majority of the decking is present. Two anchors are present and visible lying on the bottom off either side of the bow. A wood-stocked bower anchor is partially buried on the port side still attached to its anchor chain (Figure

Figure 32 Bow with missing bowsprit (Photo by Chris Kraska, MAST)

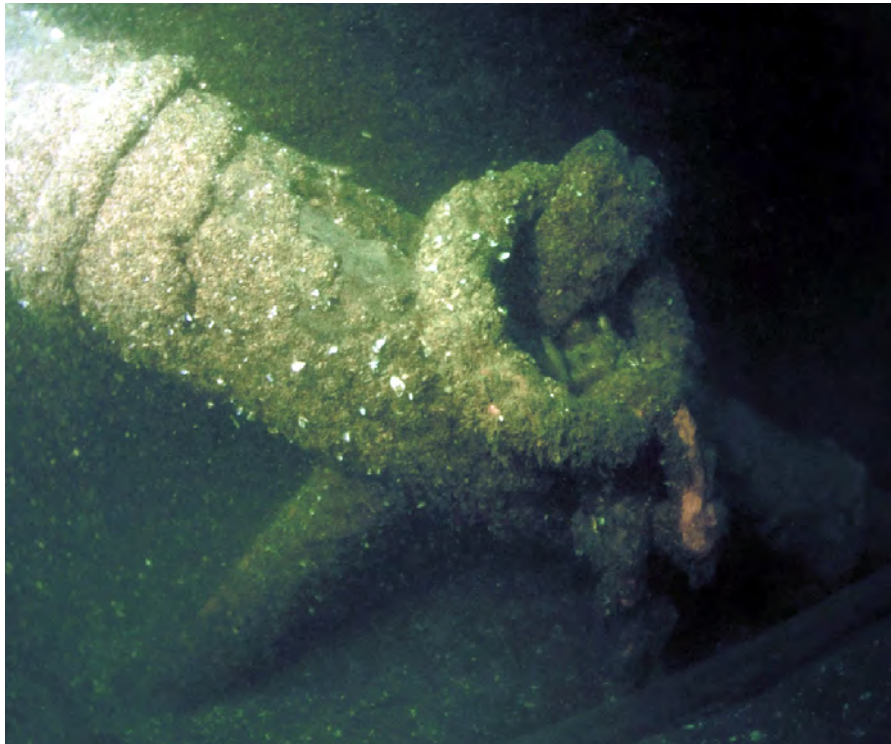
33). A metal stream or small bower anchor, with a 90 degree-shaped wooden cathead still attached to it, is mostly buried on the starboard side with a grind stone on top of it (Figure 34).

Figure 33 Wood-stock bower anchor, port side (Photo by Chris Kraska, MAST)

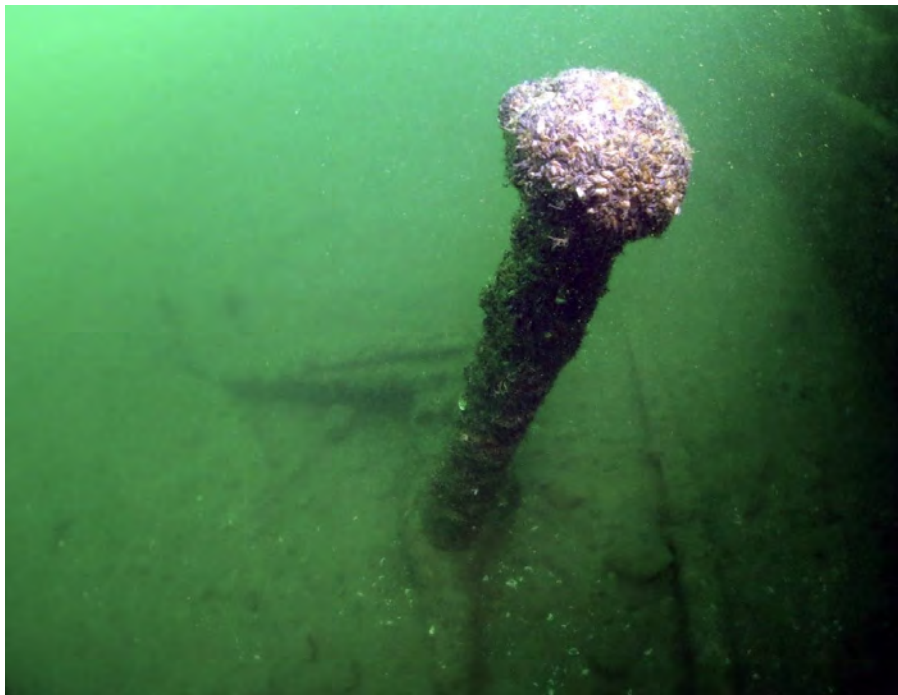
**Figure 34 Metal stream or small bower anchor with attached cathead, starboard side
(Photo by David VanZandt, CLUE)**

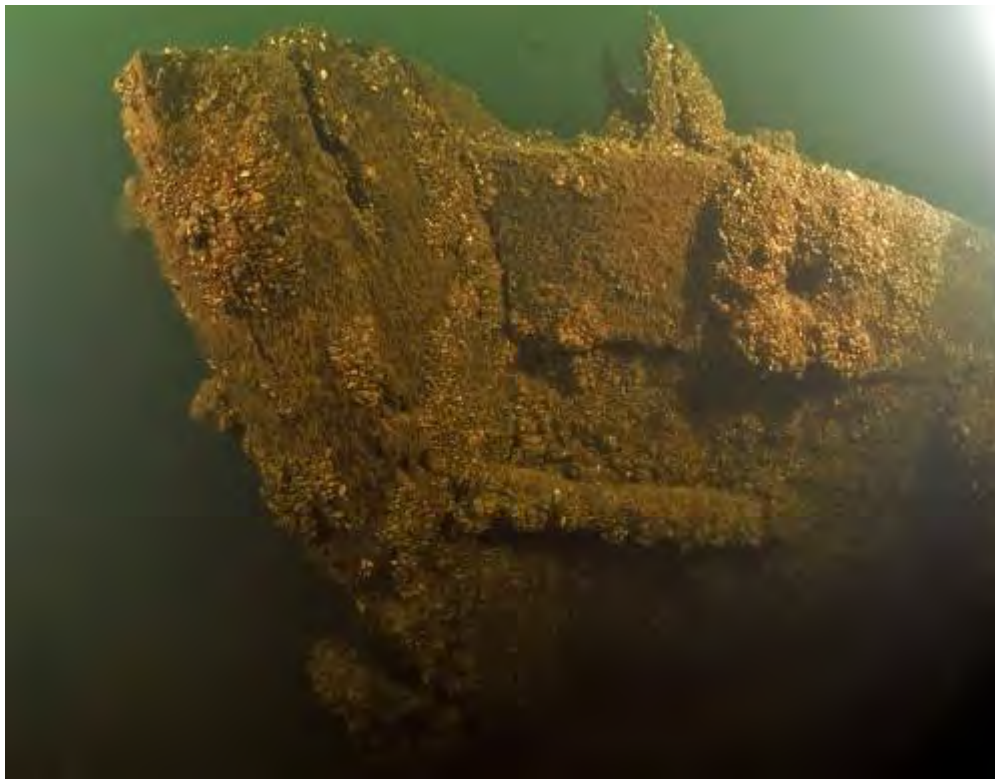
The bow of the ship features a prominent cutwater with a notch for the missing bowsprit (Figure 35). The disarticulated bowsprit rests on the bottom 42 feet to the east of the bow (Figure 36). A windlass (Figure 37) is located on the forward deck just aft of the bowsprit notch (Figure 38). Aft of the windlass is a small square access opening in the deck to the chain locker, which is filled with anchor chain. Two separate anchor chains run from the chain locker. The port anchor chain runs from the chain locker through its spurling pipe and loops back into the chain locker. It then comes back out of the chain locker where it wraps around the port whelp of the windlass (Figure 39). From the whelp it continues its run along the deck to the port hawse pipe and presumably out to the partially buried port anchor. The starboard anchor chain runs out of its spurling pipe and is separated at this point (Figure 40). After the separation the remaining starboard anchor chain wraps around the starboard whelp of the windlass. From the starboard whelp it continues it runs along the deck (Figure 41) to the apparently ripped out hawse pipe continuing off the deck and down the side of the ship presumably out to the partially buried starboard anchor.

Figure 35 Bow and cutwater (Photo by Jack Papes, Akron, Ohio)

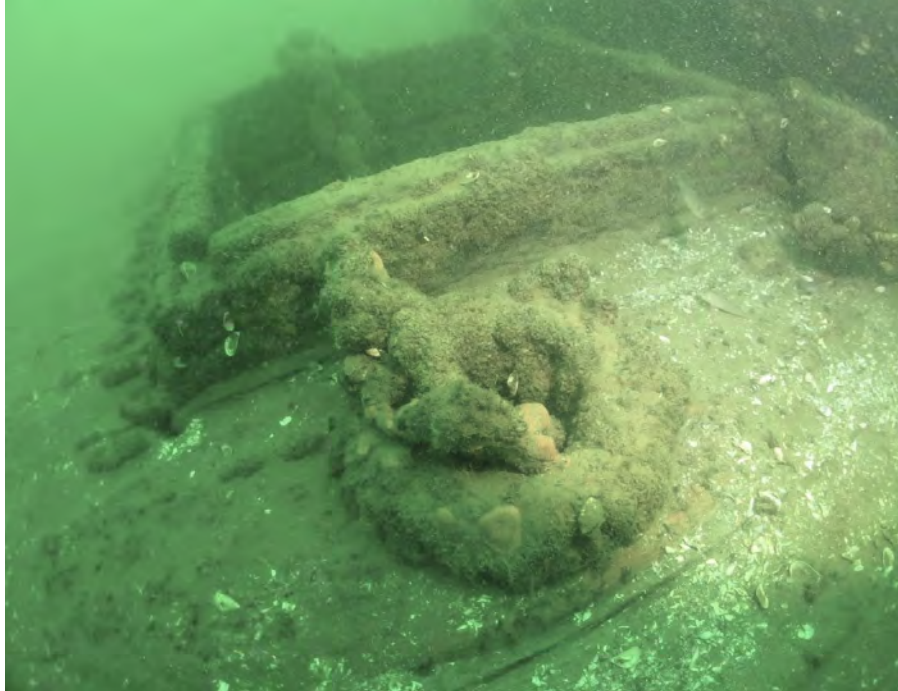
**Figure 40 Chain locker and broken anchor chain coming out of starboard spurling pipe
(Photo by David VanZandt, CLUE)**

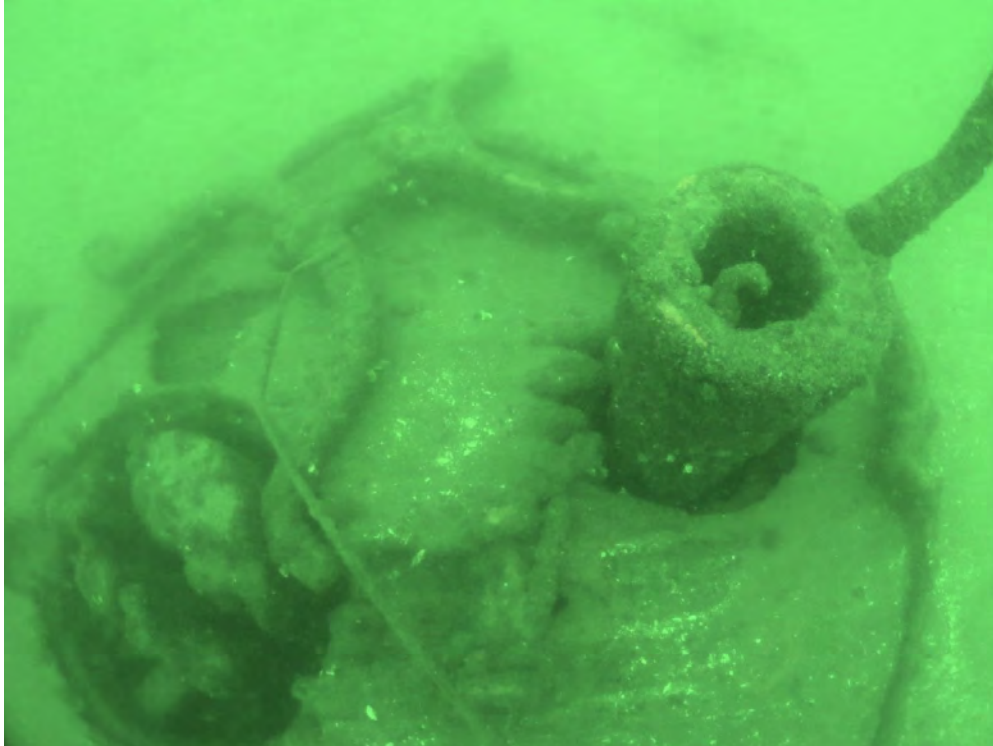
Aft of the chain locker is a single-barrel hand pump (Figure 42) along with the remains of the foremast located just behind this pump and broken off at deck level (Figure 43). Along the railings adjacent to the foremast are the remains of six large deadeyes on each side. The deadeyes are no longer attached to the railings and their chainplates are bent down parallel to the hull suggesting the mast was violently wrested from the standing rigging (Figure 44). The large number of deadeyes is a good indicator that the foremast was square-rigged.

Figure 43 Pump and foremast remains (Photo by David VanZandt, CLUE)

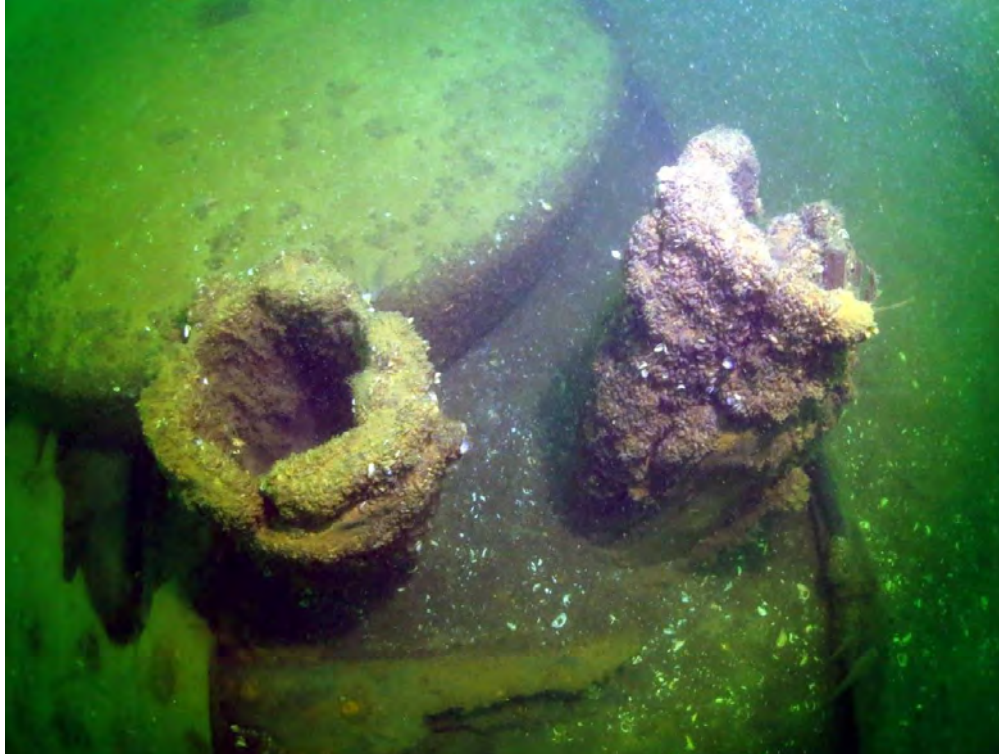
A single large 5-foot diameter grindstone rests on the centerline wedged against a two-barreled wooden pump immediately behind the aft slot (Figure 52). The mainmast is missing but it stood behind this area as evidenced by the chainplates on the sides of the ship adjacent to this area. There are three deadeyes intended for each side. The deadeyes are missing on the starboard side railing (Figure 53) while two of the three deadeyes remain on the port side railing (Figure 54). A strip of missing centerline decking runs aft from the pump to another cargo hatch (Figure 55).

Figure 52 Two-barreled wooden pump and grindstone (Photo by David VanZandt, CLUE)

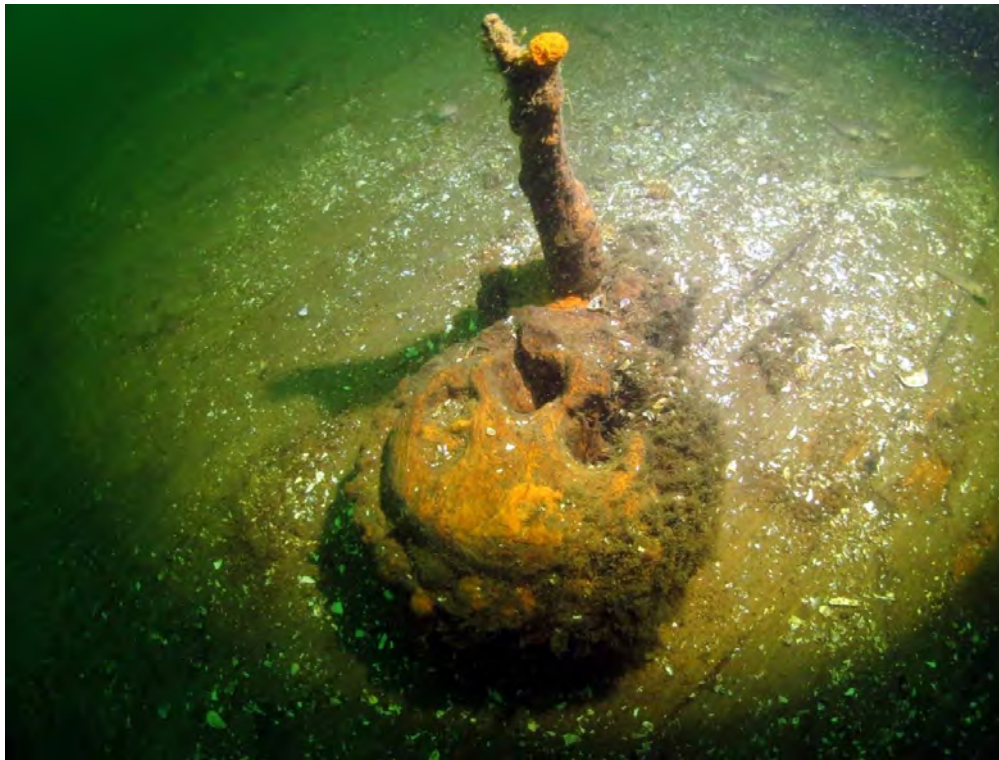
Figure 53 Dis-articulated deadeye on deck (Photo by David VanZandt, CLUE)

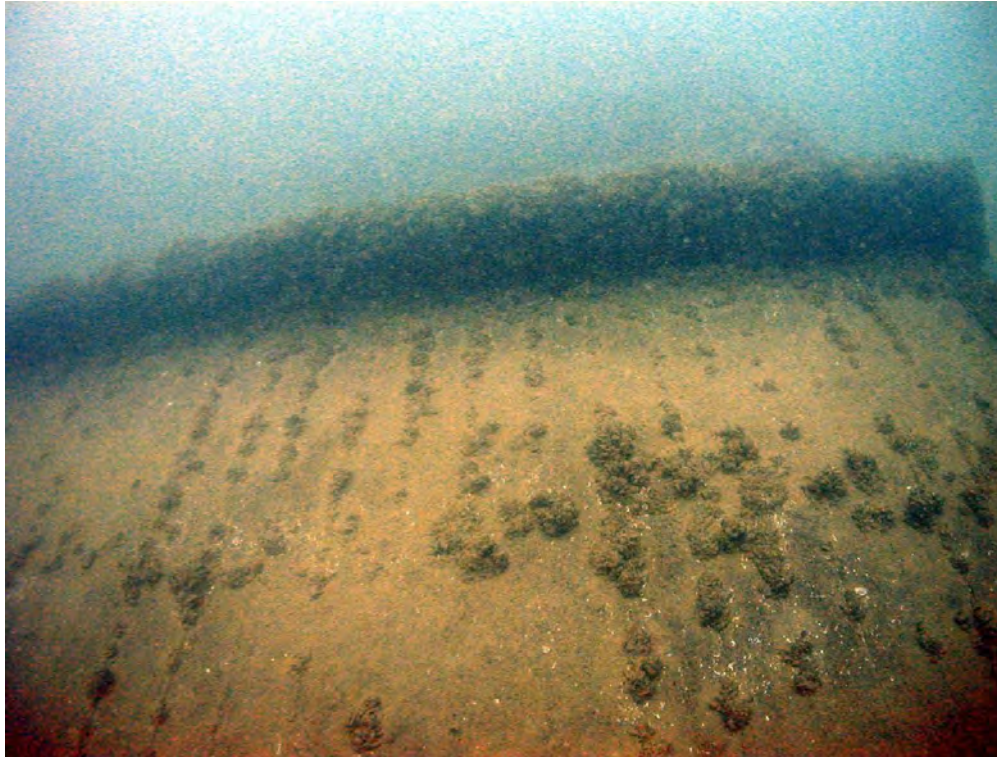
Astern of the aft cargo hatch is a raised wooden combing that spans the entire beam and once formed the front of the now missing cabin (Figure 56). Grindstones are wedged against this combing and the starboard railing but do not spill into the cabin space (Figure 57). Four floor joists are present where the cabin floor was once located (Figure 58).

Figure 56 Aft cabin combing (Photo by David VanZandt, CLUE)

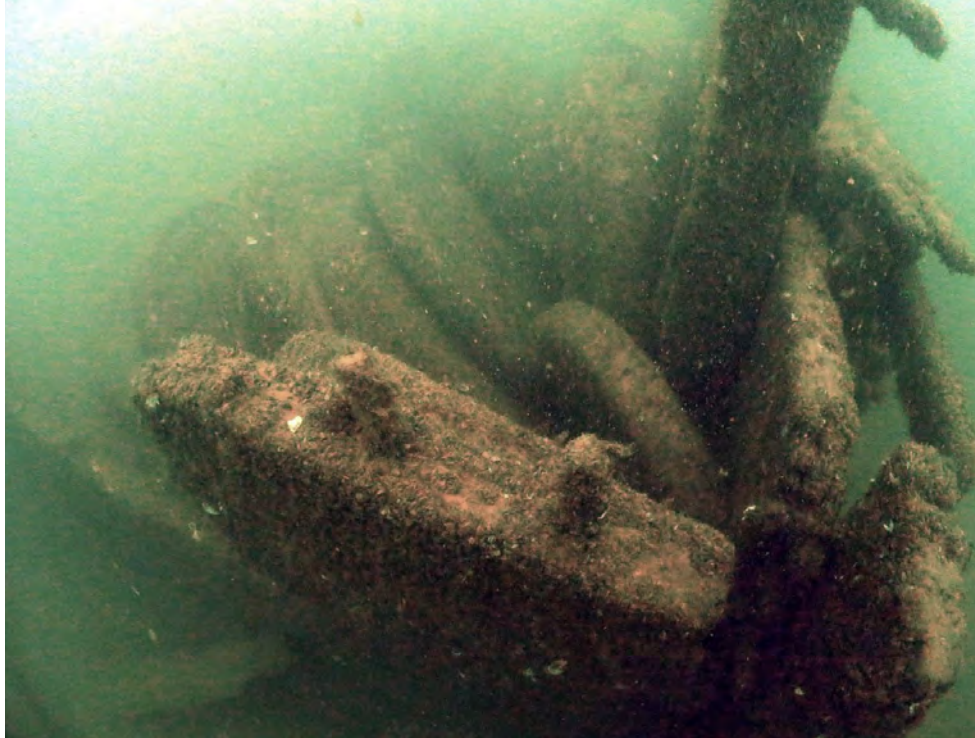
Figure 57 Grindstones piled up at cabin combing interface (Photo by David VanZandt, CLUE)

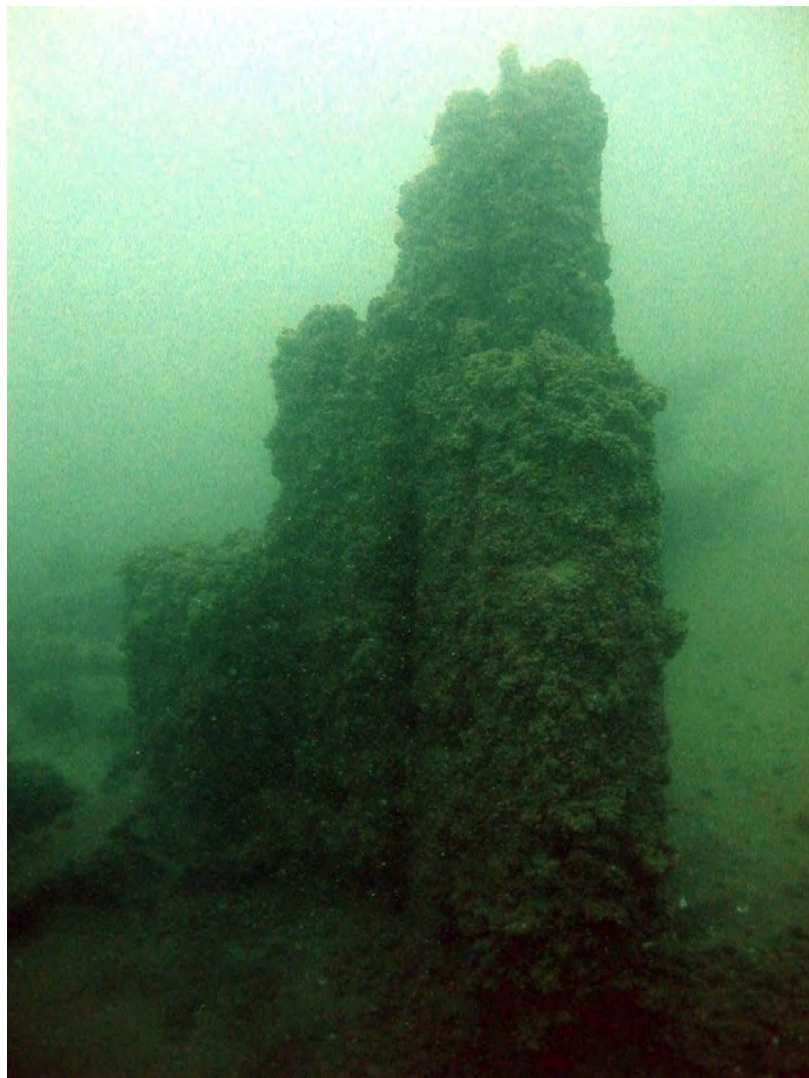
The transom is missing, and the rudderpost, turned slightly to port, stands high off the bottom (Figure 59). The rudder cap, which would have been mounted on top of the rudderpost, can be seen lying inside the cabin on the port side (Figure 60). A line of grindstones that spilled from the boat as it drifted and sank is visible in the distance behind the stern running out across the bottom of the lake. The wreck's length and breadth were measured at 125 feet and 23 feet respectively which compares closely to the 127 feet by 24 feet indicated on the *Sultan's* various enrollments.

Figure 59 Rudder post (Photo by David VanZandt, CLUE)

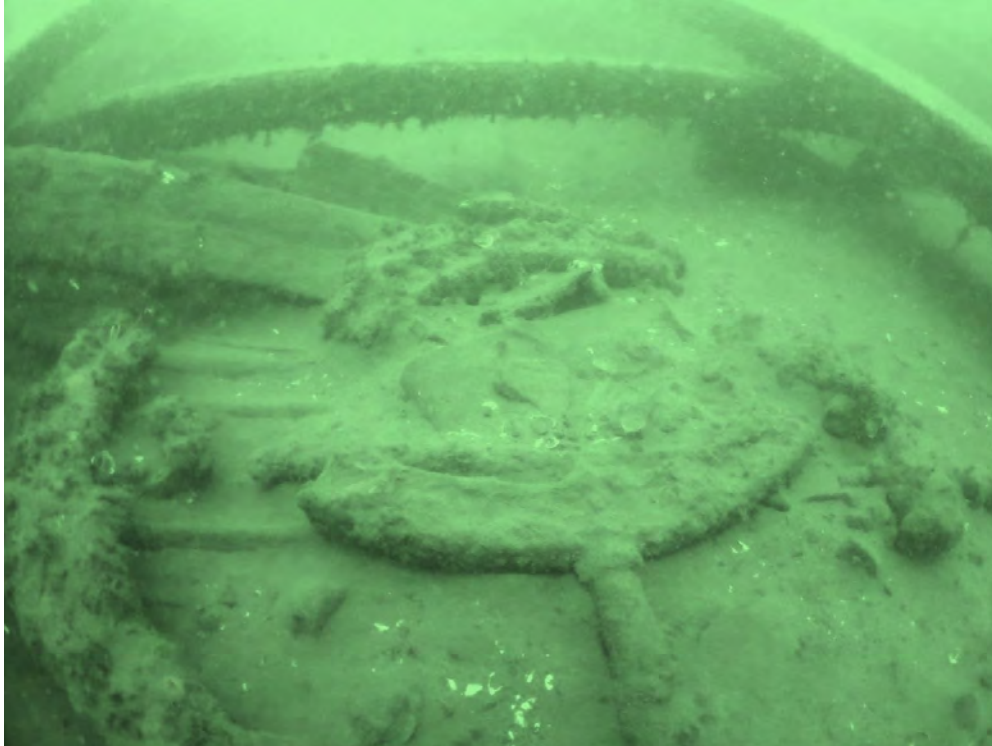
The deck of the *Sultan* is strewn with a variety of dis-articulated deck hardware. Some of the hardware has been identified and some has yet to be. One of the most identifiable pieces of deck hardware to be found is the broken ship's wheel (Figure 61) located near the stern where the cabin once stood.

Figure 61 Broken ship's wheel (Photo by David VanZandt, CLUE)

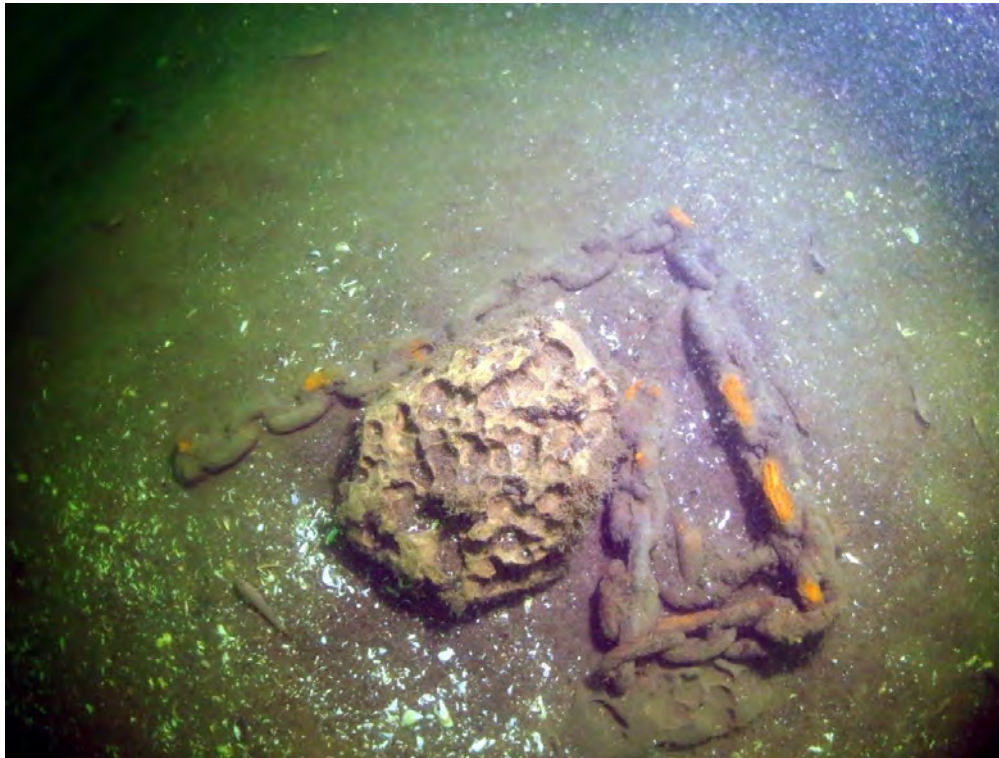
Figure 70 Dis-articulated chain on deck (Photo by David VanZandt, CLUE)
