The Wreck of the Brig *Sultan*: An Archaeological Investigation

Brig Sultan

Maritime Archaeological Survey Team

February 2016

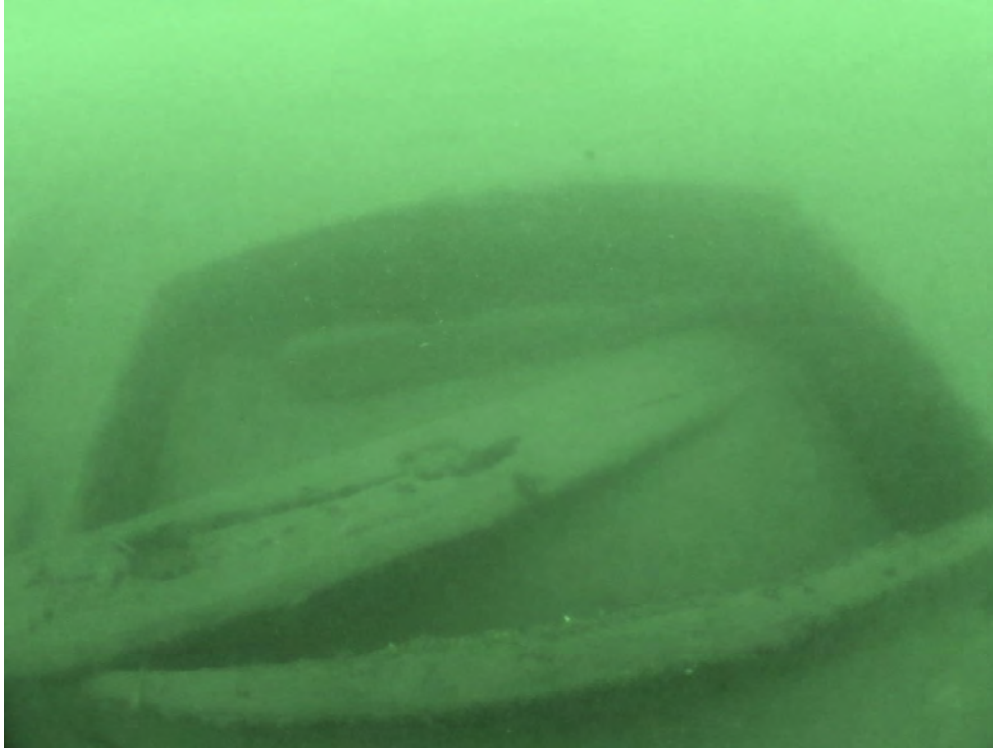
Aft of the foremast stub is a cargo hatch. Two long boards protrude out from the after side of the hatch toward the starboard side and are likely remnants of the secondary cargo of lumber (Figure 49). Along the centerline of the vessel is a small slot in the deck followed by a small hatch aft of the slot (Figure 50) and another small slot (Figure 51). This is the location of the centerboard although no centerboard box is apparent inside the silt-filled hold as viewed through the center hatch and no centerboard winch is present at the aft slot but the two forward mounting holes for the winch appear to be on the deck

Figure 49 Forward cargo hatch (Photo David VanZandt, CLUE)

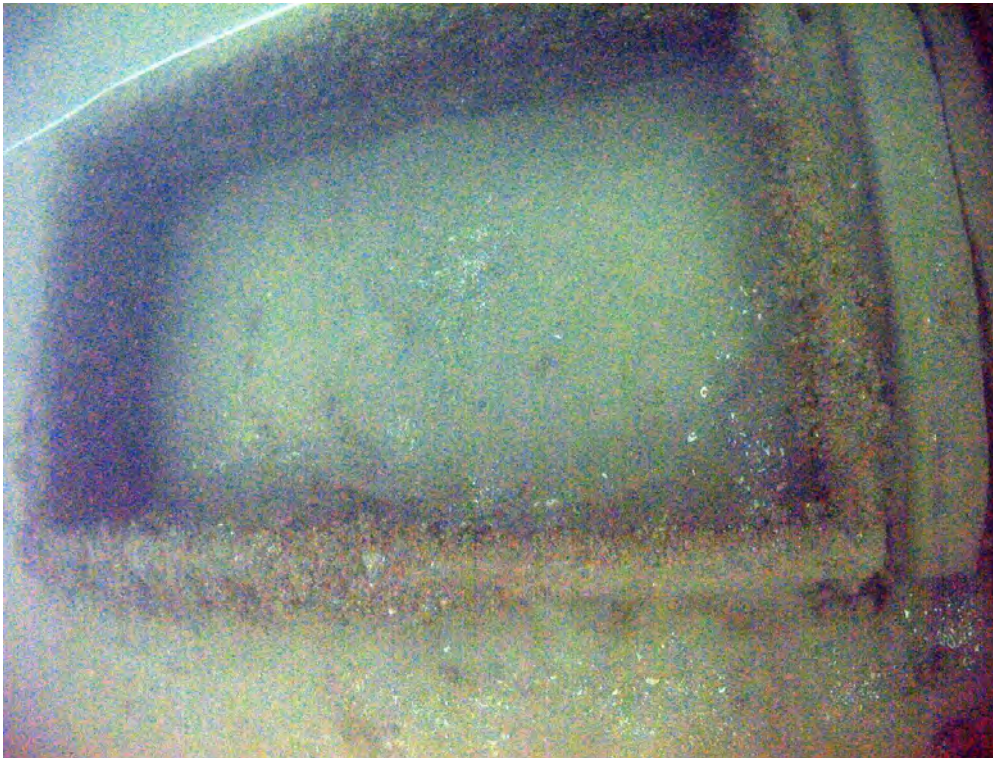
Figure 50 Small center hatch (Photo by David VanZandt, CLUE)

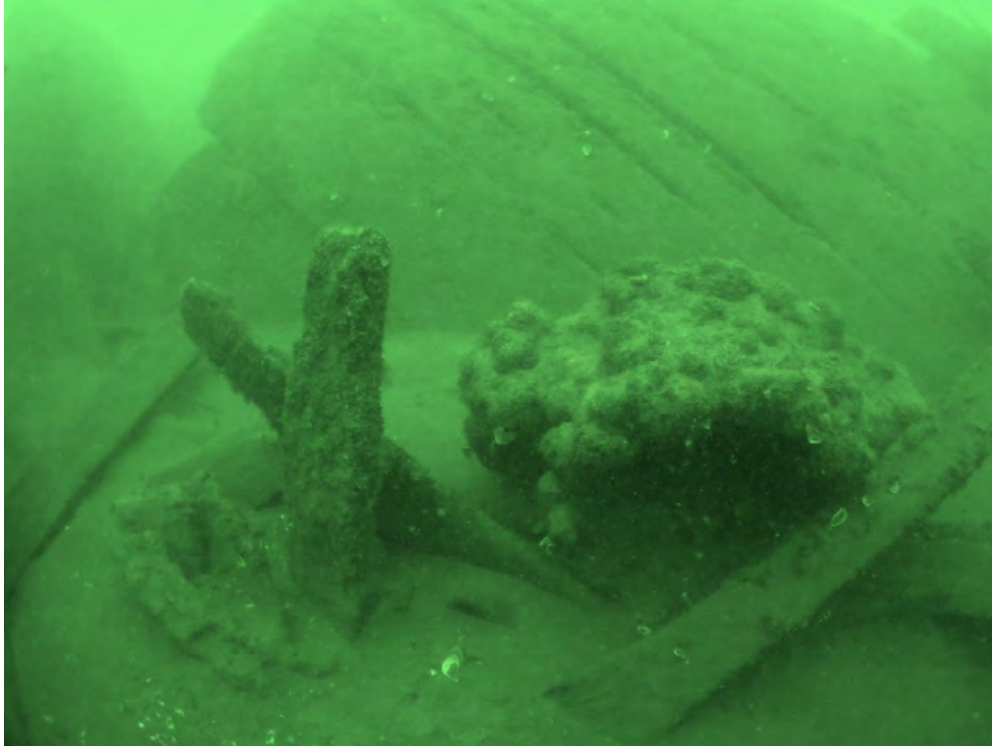
Figure 60 Rudder post cap (Photo by David VanZandt, CLUE)

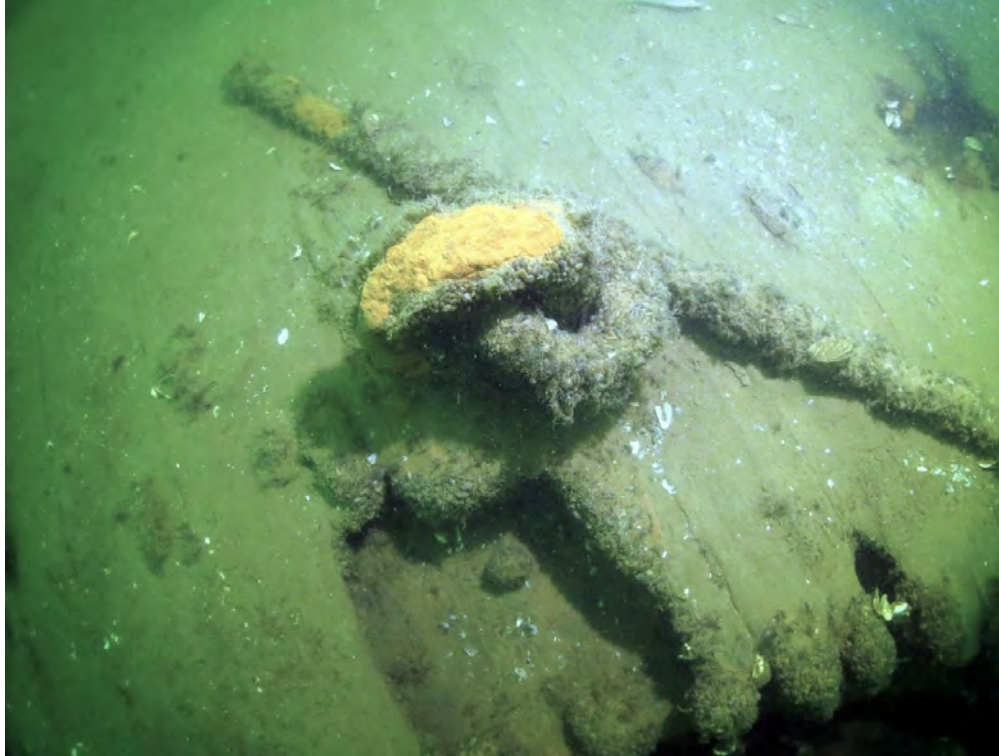
Figure 65 Misc. deck hardware aft of main mast stub (Photo by David VanZandt, CLUE)

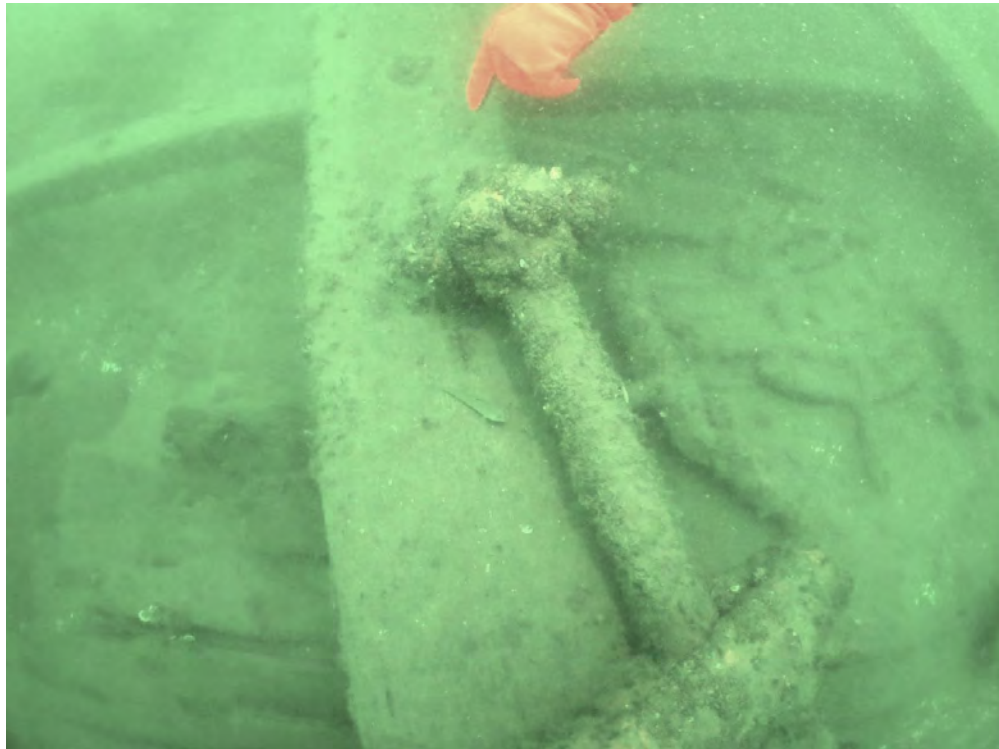
Figure 66 Misc. deck hardware (Photo by David VanZandt, CLUE)

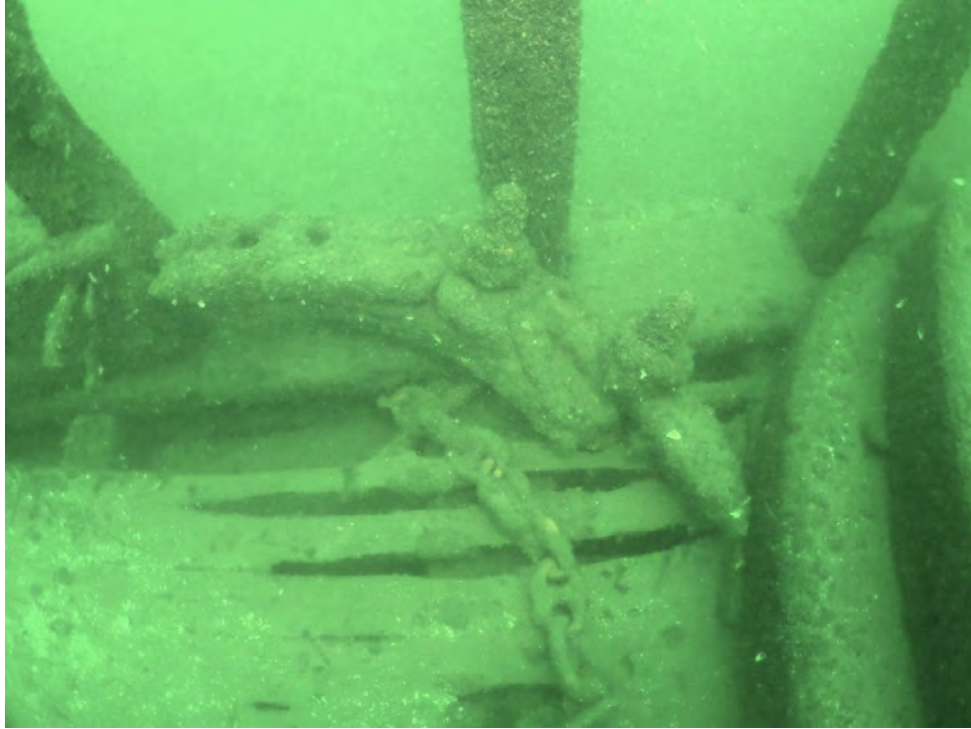
Figure 67 Misc. chain and deck hardware, possible piece of the starboard cathead (Photo by David VanZandt, CLUE)
