The Wreck of the Brig *Sultan*: An Archaeological Investigation

Brig Sultan

Maritime Archaeological Survey Team

February 2016

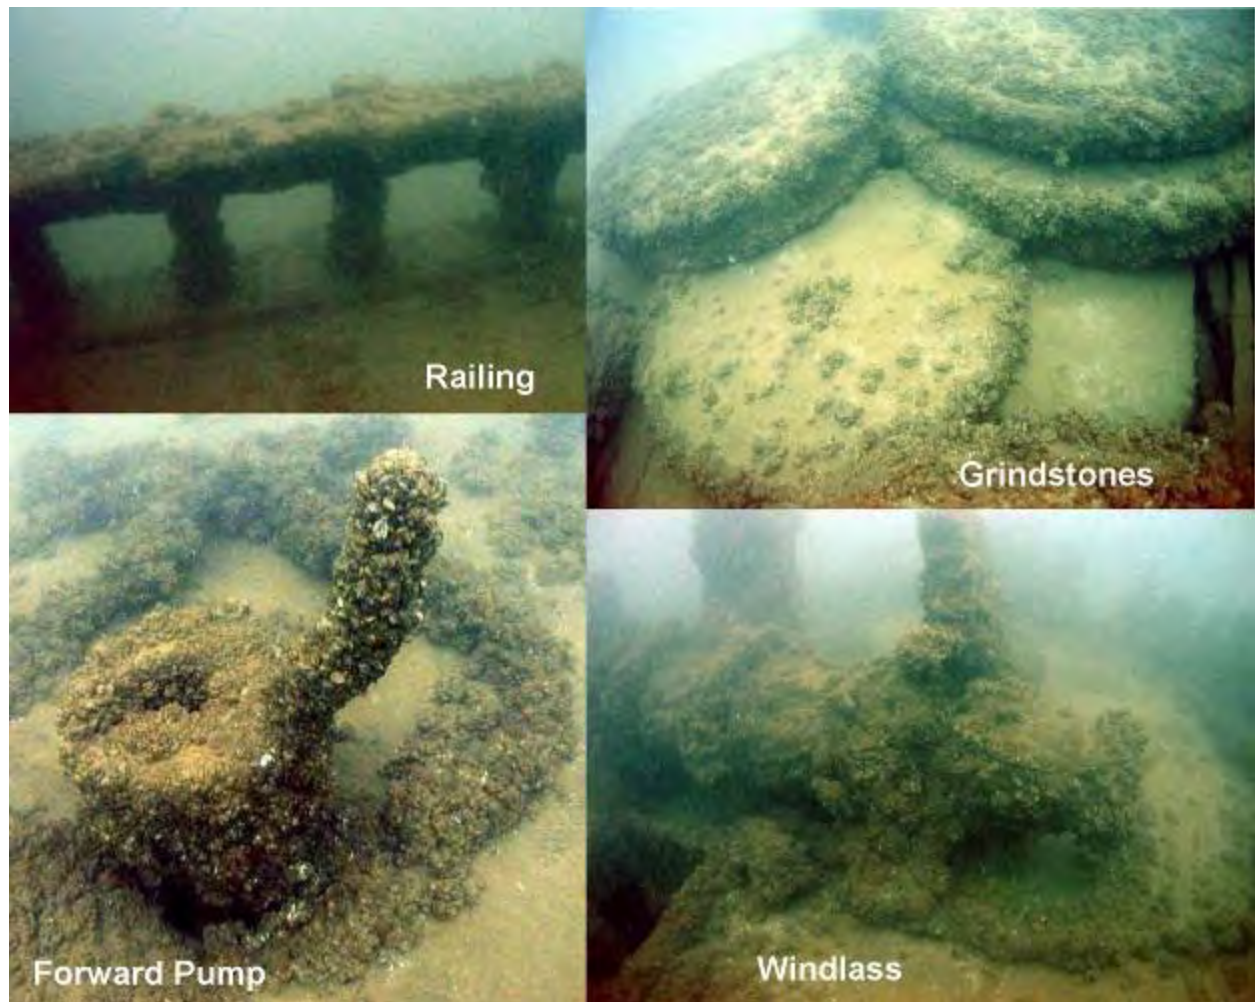
Figure 2 *Sultan* reconnaissance survey photos (Photos by David VanZandt, CLUE)

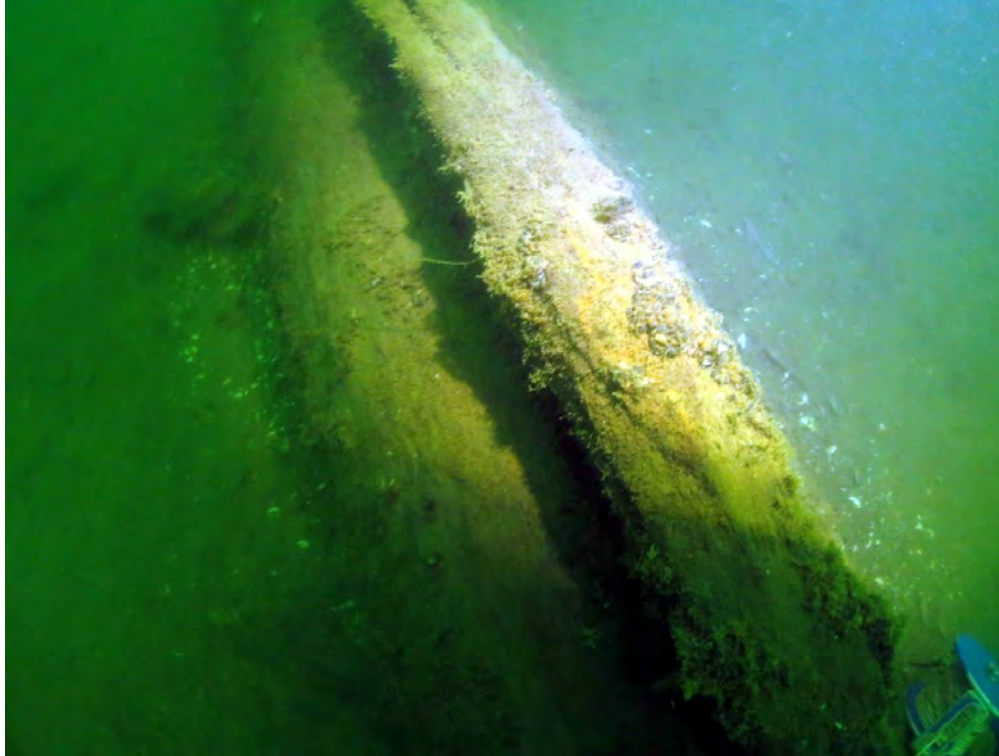
The bow of the ship features a prominent cutwater with a notch for the missing bowsprit (Figure 35). The disarticulated bowsprit rests on the bottom 42 feet to the east of the bow (Figure 36). A windlass (Figure 37) is located on the forward deck just aft of the bowsprit notch (Figure 38). Aft of the windlass is a small square access opening in the deck to the chain locker, which is filled with anchor chain. Two separate anchor chains run from the chain locker. The port anchor chain runs from the chain locker through its spurling pipe and loops back into the chain locker. It then comes back out of the chain locker where it wraps around the port whelp of the windlass (Figure 39). From the whelp it continues its run along the deck to the port hawse pipe and presumably out to the partially buried port anchor. The starboard anchor chain runs out of its spurling pipe and is separated at this point (Figure 40). After the separation the remaining starboard anchor chain wraps around the starboard whelp of the windlass. From the starboard whelp it continues it runs along the deck (Figure 41) to the apparently ripped out hawse pipe continuing off the deck and down the side of the ship presumably out to the partially buried starboard anchor.

Figure 36 Bowsprit (Photo by David VanZandt, CLUE)

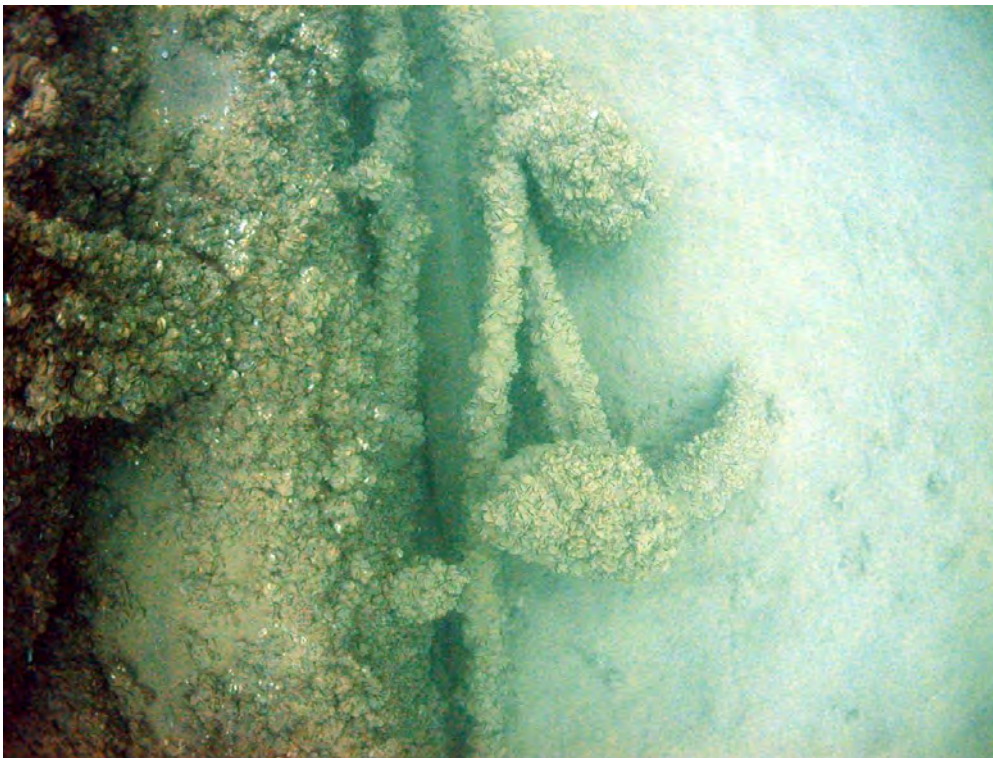
Figure 44 Chain plates and deadeyes (Photo by David VanZandt, CLUE)

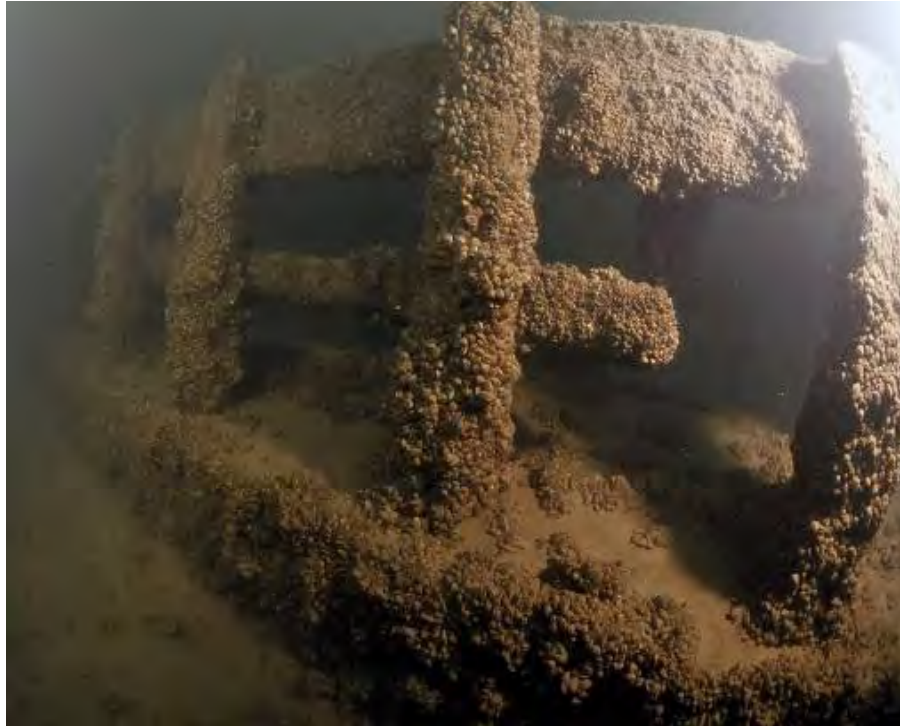
The wreck has an obvious list of about 30 degrees to starboard. The railings on both the starboard (Figure 45) and port sides (Figure 46) are mostly intact. Round grindstones are piled up on the deck along the inboard starboard railing in stacks of one, two, or three stones high and in several rows (Figure 47). The grindstones start near the foremast and continue all the way to the stern (Figure 48). The larger stones, about 5.5 feet in diameter, are located forward, and the smaller stones, about 3.5 feet in diameter, are located toward the stern.

Figure 45 Intact starboard railing. (Photo by Jack Papes, Akron, Ohio)

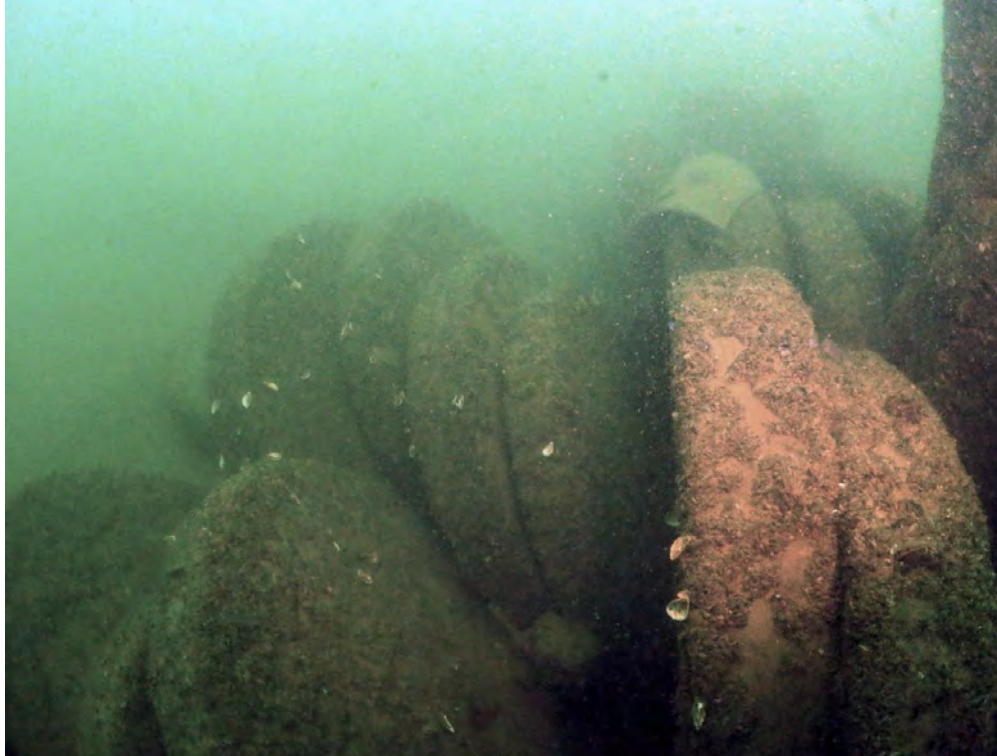
Figure 48 Grindstones along starboard side (Photo by David VanZandt, CLUE)

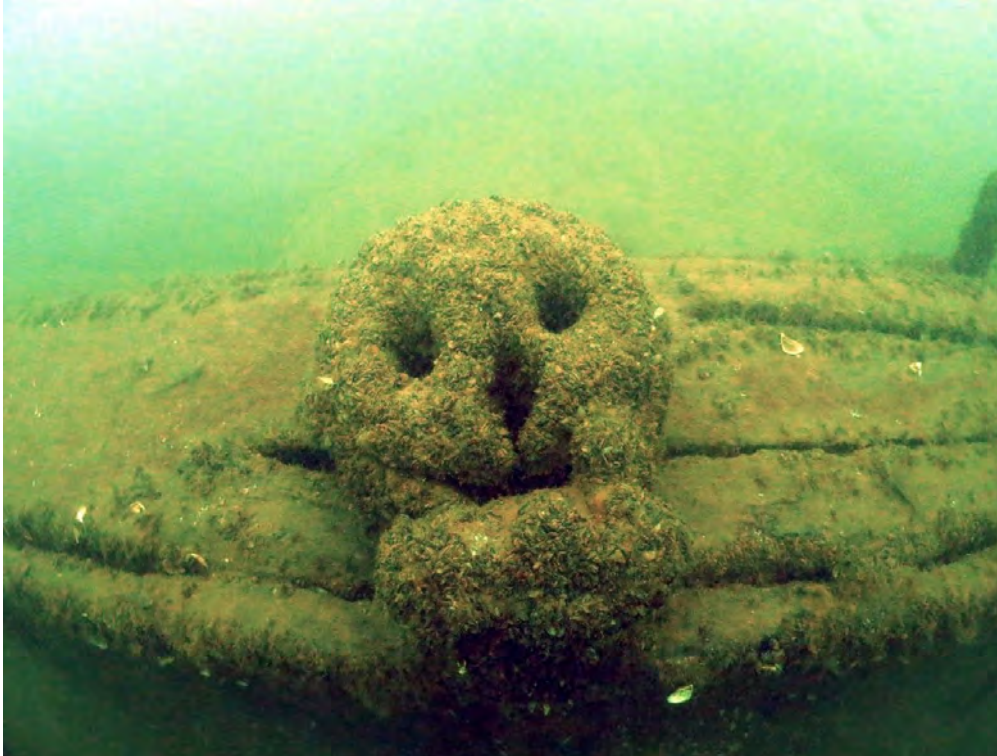
Figure 54 Attached deadeye (Photo by David VanZandt, CLUE)

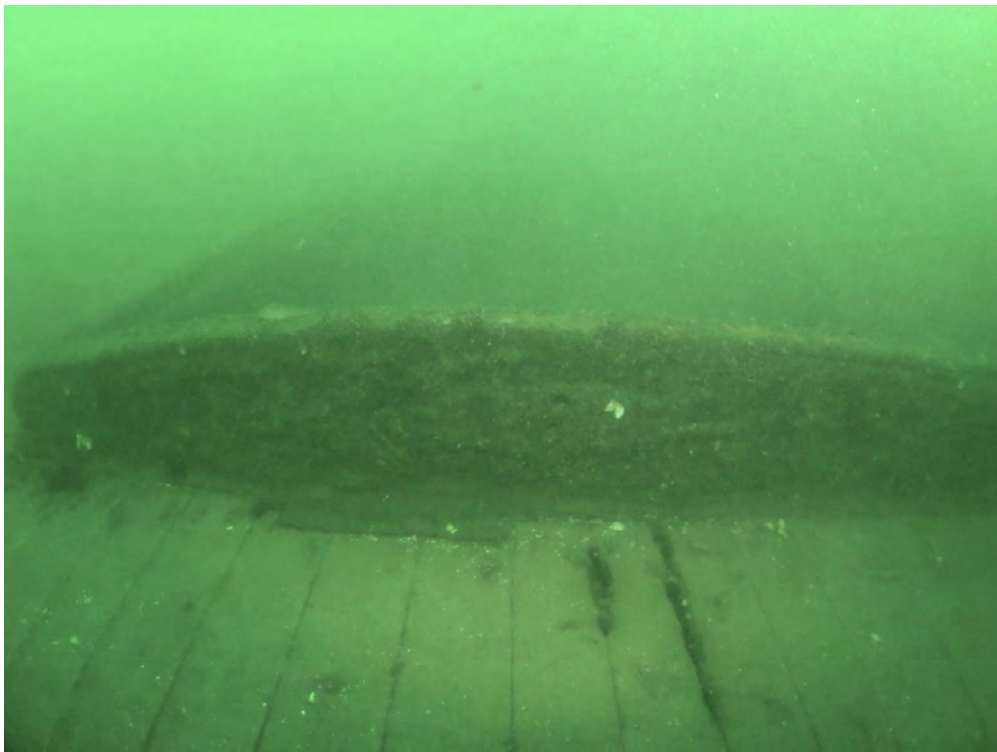
Figure 55 Aft hatch (Photo by David VanZandt, CLUE)

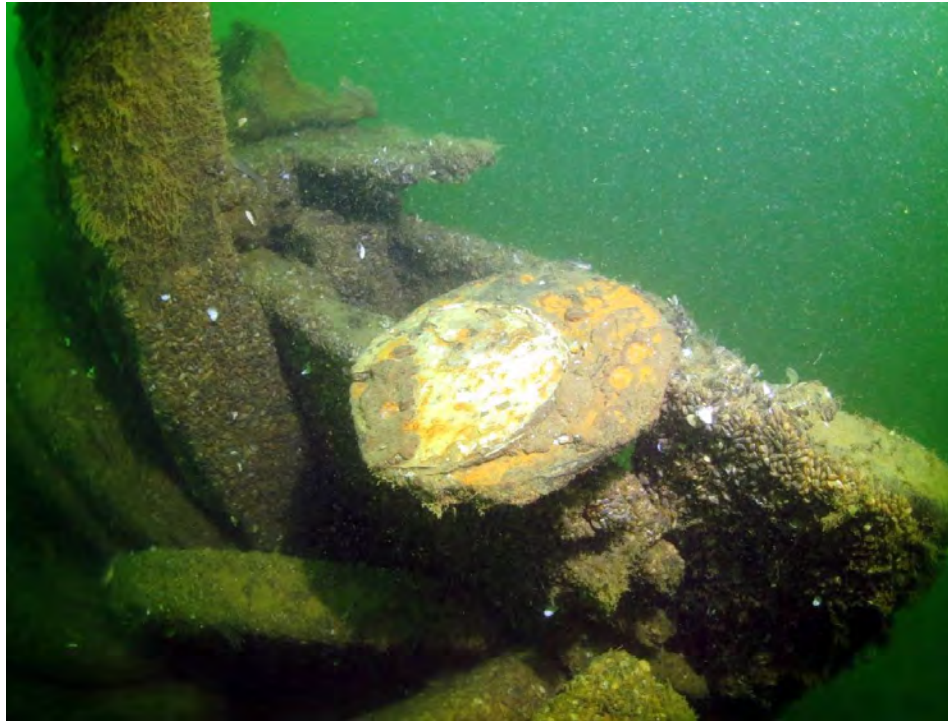
Figure 63 Possible stove part (Photo by David VanZandt, CLUE)

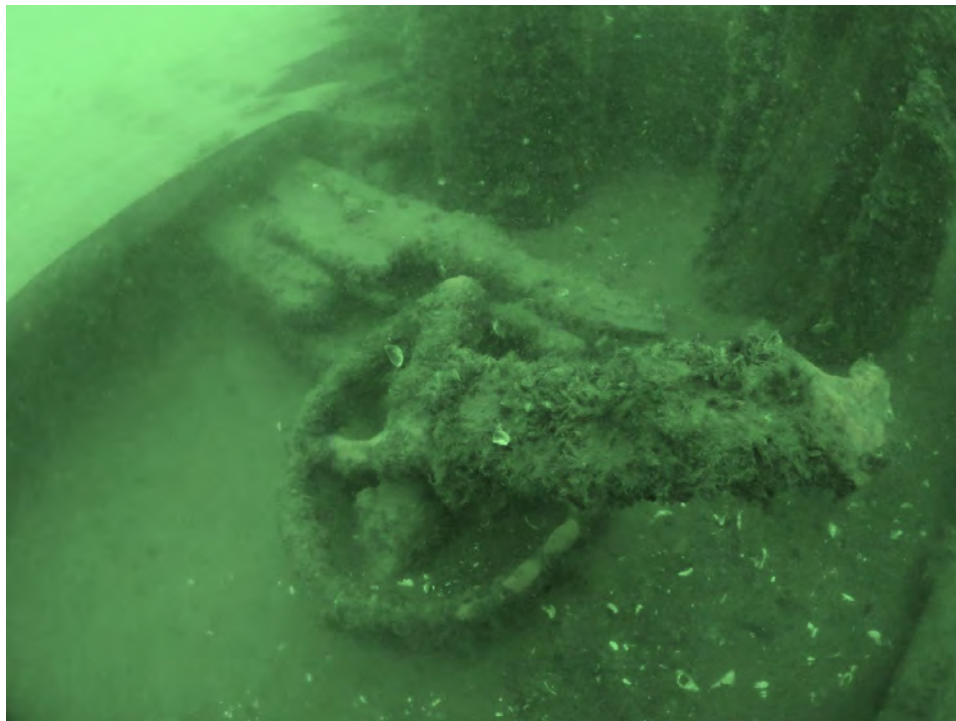
Figure 64 Possible mechanical cross-head near the two-barreled pump (Photo by David VanZandt, CLUE)

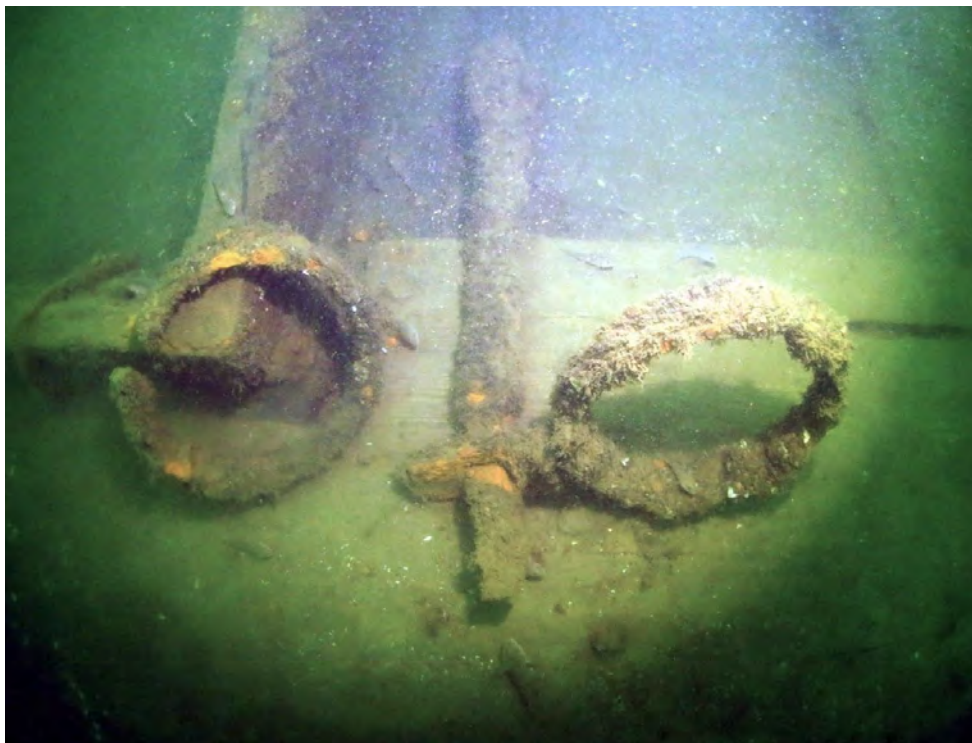
Figure 68 Double-pump mounting rings (Photo by David VanZandt, CLUE)

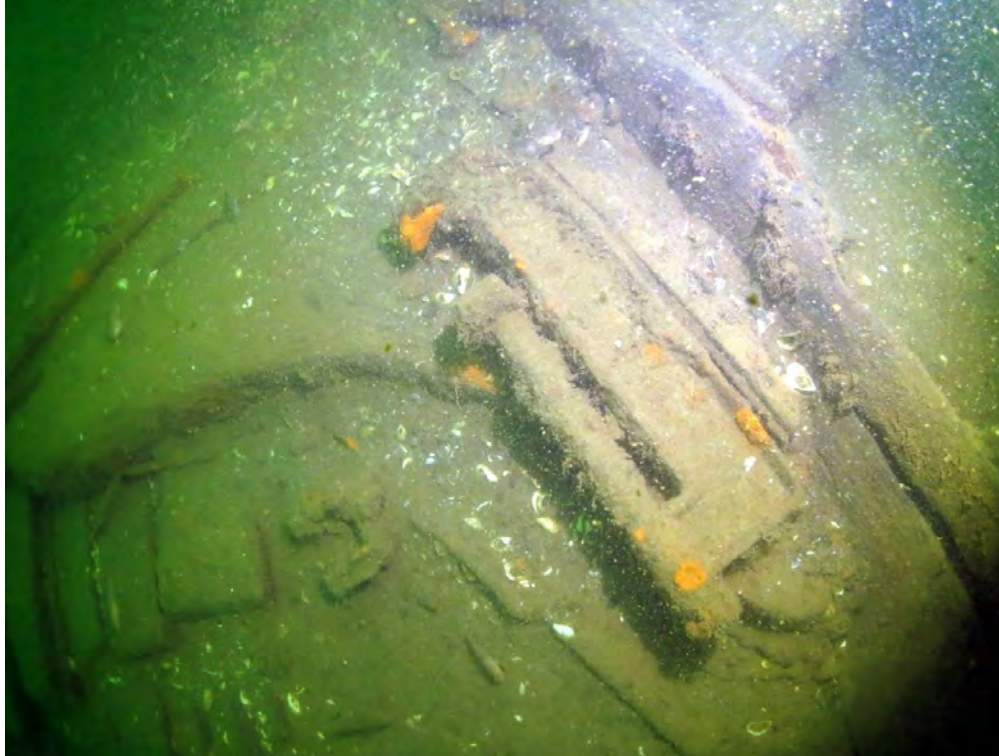
Figure 69 Metal clamp or vise (Photo by David VanZandt, CLUE)

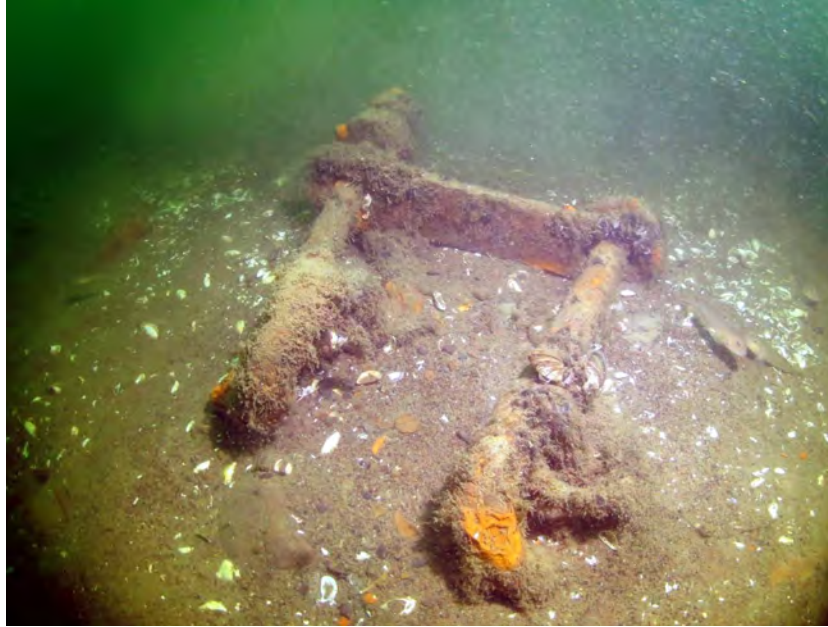
Figure 71 Metal clamp located off of the bow (Photo by David VanZandt, CLUE)

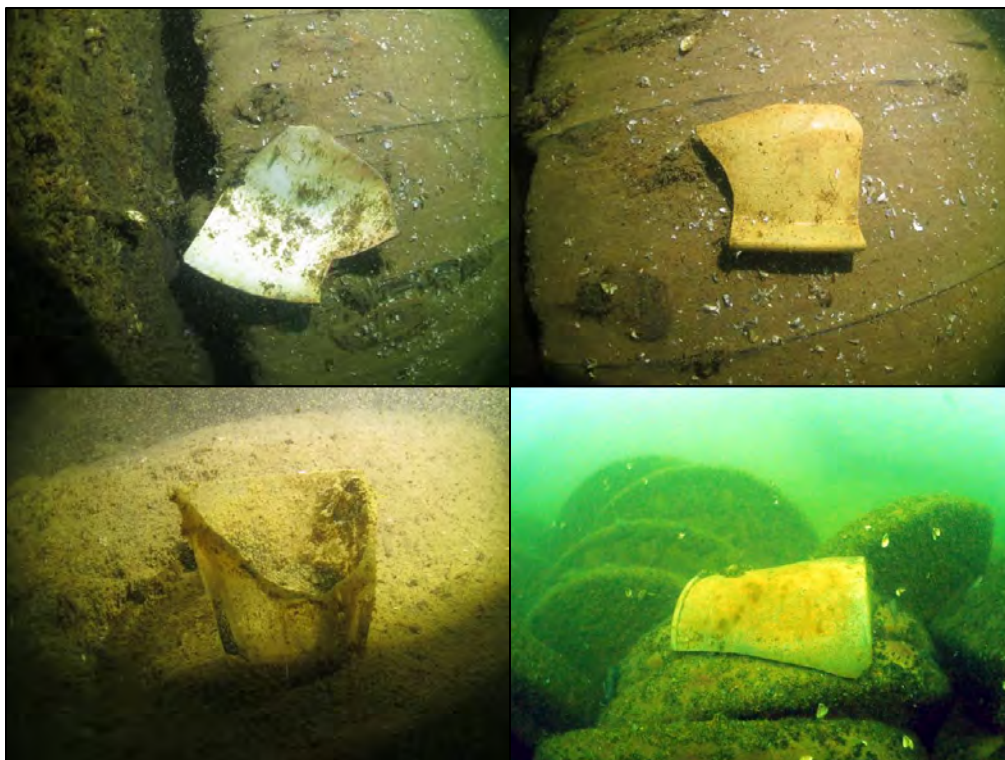
Additional ceramic, pottery, and glass items have been located on or around the wreck and a formal analysis of this assemblage will be performed at a later date (Figure 75, Figure 76).

Figure 76 Various ceramics, pottery, and glass (Photos by David VanZandt, CLUE)
